**Federal Clean Water Act  
Section 319 Grant**  
2003-0043

**Muskegon River Watershed Assembly**  
Telephone: 231-591-2324  
Fax: 231-591-2306  
Email: mrwa@ferris.edu

## Bear Creek (Muskegon County) Transition/Implementation 1

September 27, 2004 through June 30, 2007

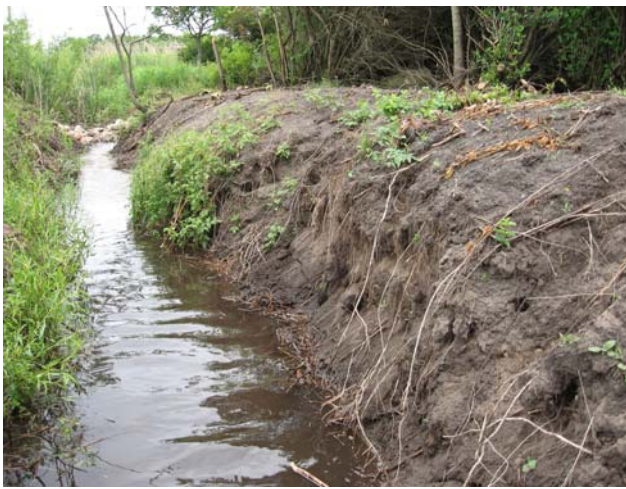
**Site BC2 (Before):** This eroding streambank was contributing sediment to Bear Creek. The severe slope and sandy conditions were contributing to the bank erosion.

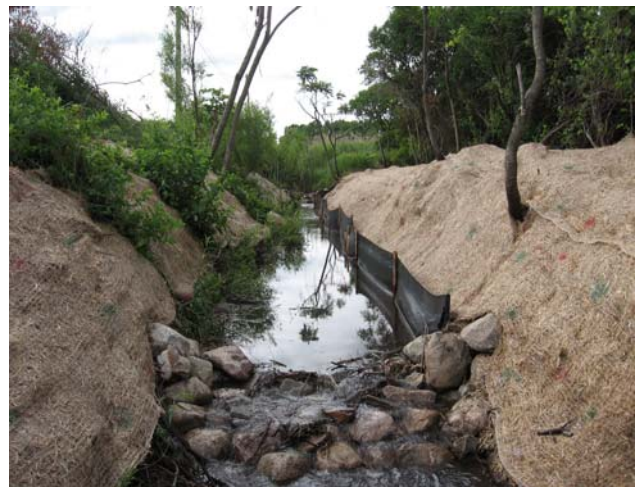
**Site BC2 (After):** Three (3) check dams were placed along this tributary of Bear Creek; the bank was reshaped, seeded with native grasses and covered with an erosion control blanket.

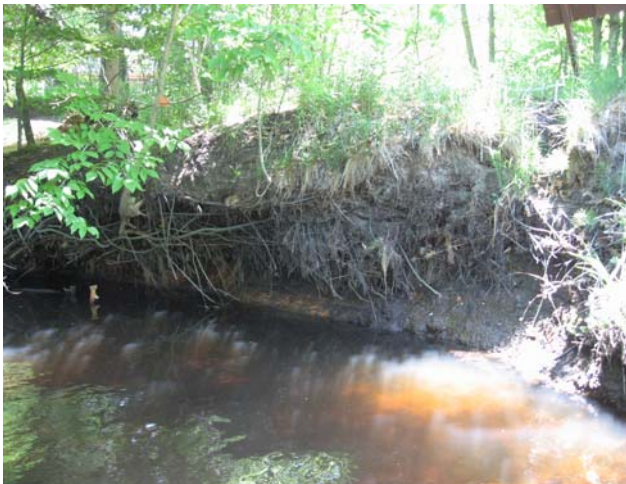
**Site 17 (Before):** Undercutting was occurring on this streambank and was causing the upper bank to collapse, contributing sediment to Bear Creek.

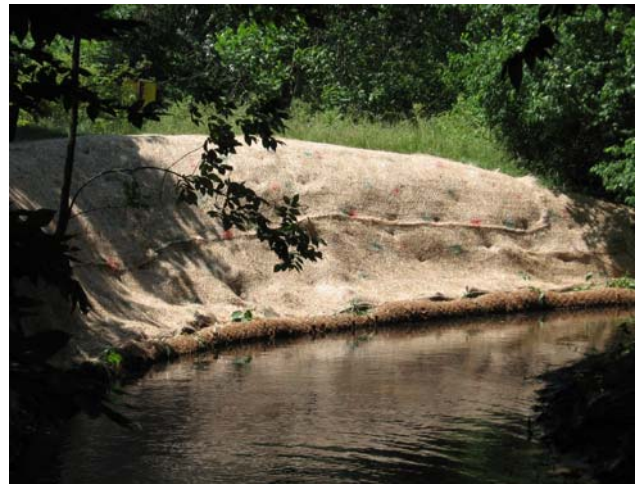
**Site 17 (After):** Coir (Fiber) Logs were installed to stabilize the toe of the bank. The upper bank was reshaped, seeded with native grasses and covered with an erosion control blanket.
