MICHIGAN DEPARTMENT OF ENVIRONMENTAL QUALITY  
WATER RESOURCES DIVISION  
FEBRUARY 2011

STAFF REPORT

BIOLOGICAL AND WATER CHEMISTRY SURVEYS OF SELECTED STATIONS IN THE  
RUDDIMAN CREEK WATERSHED  
MUSKEGON COUNTY, MICHIGAN  
JUNE 2009

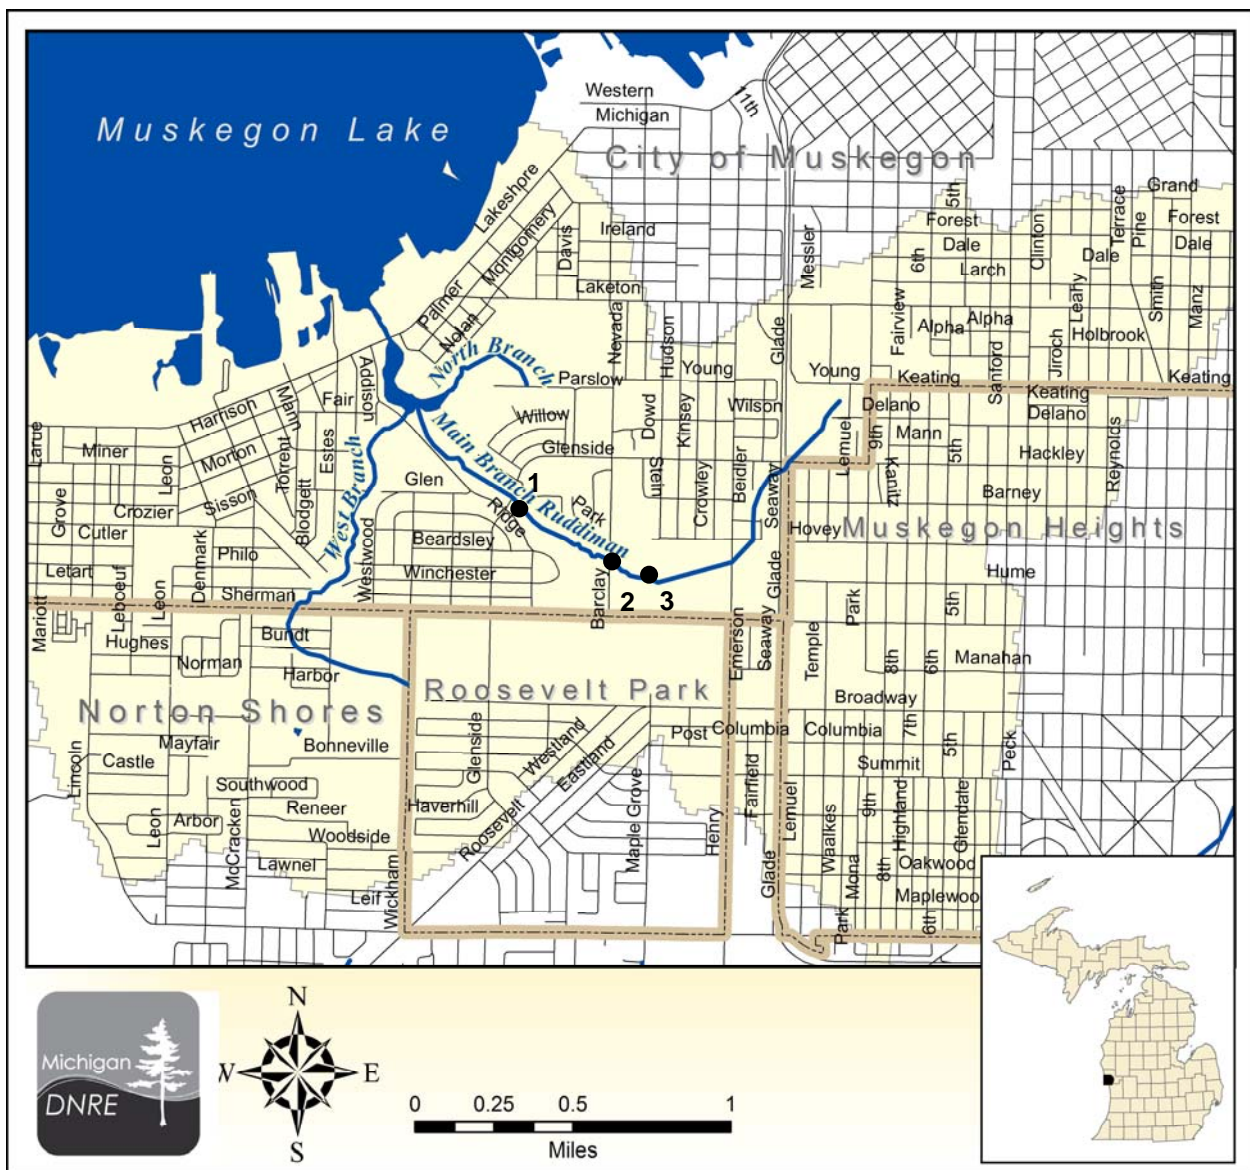
Figure 1. 2009 biosurveys of the Ruddiman Creek watershed, Muskegon County, Michigan.

Water chemistry samples were collected and preserved from three stations (Table 1, Figure 1) according to the Michigan Department of Environmental Quality (MDEQ) protocol (MDEQ, 1994). The macroinvertebrate community and physical habitat were qualitatively assessed at two stations, using the SWAS Procedure 51 (MDEQ, 1990; Creal et al., 1996) for wadeable streams. The macroinvertebrate communities were assessed and scored with metrics that rate water bodies from excellent (+5 to +9) to poor (-5 to -9). Scores from +4 to -4 are rated acceptable. Negative scores in the acceptable range are considered tending towards a poor rating, while positive scores in the acceptable range are tending towards an excellent rating. Habitat evaluations are based on 10 metrics, with a possible maximum total score of 200. A station habitat score of >154 is characterized as having excellent habitat, 105-154 is good, 56-104 is marginal, and <56 is poor.

Ruddiman Creek is located near the city of Muskegon on the west side of the lower peninsula of Michigan and is a tributary to Muskegon Lake. The watershed covers approximately 6.5 square miles. The Ruddiman Creek watershed lies within four municipalities; the city of Muskegon, Muskegon Heights, Roosevelt Park, and Norton Shores. The Ruddiman Creek watershed is highly urbanized (i.e., predominantly residential, industrial, and commercial land use) and stream flow is greatly impacted by storm water runoff. Sixty percent of the headwater area has been modified and flows below ground as part of the storm sewer system. Only about three percent of the entire watershed drains naturally to the creek without entering storm sewers (NOAA, 2008). The above-ground portion of Ruddiman Creek begins as a storm sewer outfall, just upstream of Barclay Avenue (Figure 1).

The macroinvertebrate community, fish community, and habitat was surveyed upstream of Glenside Boulevard (Station 1; Figure 1). The glide/pool habitat scored marginal (95; moderately-impaired) (Table 3a). Epifaunal substrate was lacking and consisted of all sand and silt. Heavy deposits forming sandbars was evidence of sedimentation. The stream channel is fairly straight through this section as a result of historic channelization. The riparian area consisted of a wide flood plain and mix of shrubs and herbaceous plants, but there was a large amount of nonnative plants. Woody debris was minimal, and there was an extensive amount of trash in the stream. There were obvious signs of extreme fluctuations of flow at this station, including a large amount of trash caught in branches high above the water surface. The macroinvertebrate community scored at the very low end of acceptable (-4) and was only 1 point away from scoring poor (Tables 3b and 3c). Nearly 400 feet of stream (from Glenside Avenue upstream to Barclay Street) was sampled for more than 45 minutes, and only 33 fish (8 taxa) were found. This resulted in a poor fish community rating (Tables 3d and 3e). There was a whitish coloration to the water at the time of sampling and a slight petroleum smell to the water and sediment in spots. No sediment samples were taken.

The macroinvertebrate community and habitat was surveyed downstream of Barclay Street (Station 2; Figure 1). The riffle/run habitat scored at the low end of good (105; slightly impaired) (Table 3a). This score is 1 point from scoring marginal. Epifaunal substrate was lacking. The substrate was 50-75 percent embedded by silt and sand. There were obvious signs of extreme

Water quality samples were taken at Stations 1 and 2 and upstream of Barclay where Ruddiman Creek first surfaces after being underground (Station 3). Parameters analyzed included metals, hardness, chemical oxygen demand, total organic carbon, nitrate+nitrites, ammonia, and total phosphorus. No WQS exceedances were found at the three stations for the parameters analyzed (Table 4).
